Investigation of Positive and Negative affect of Plants and City Furnitures By Design Criteria of Landscape Architecture In The Main Transportation Arteries of Afyon/Turkey

Sertaç GÜNGÖR^{1*} Ahmet Tuğrul POLAT¹ Metin DEMİR²

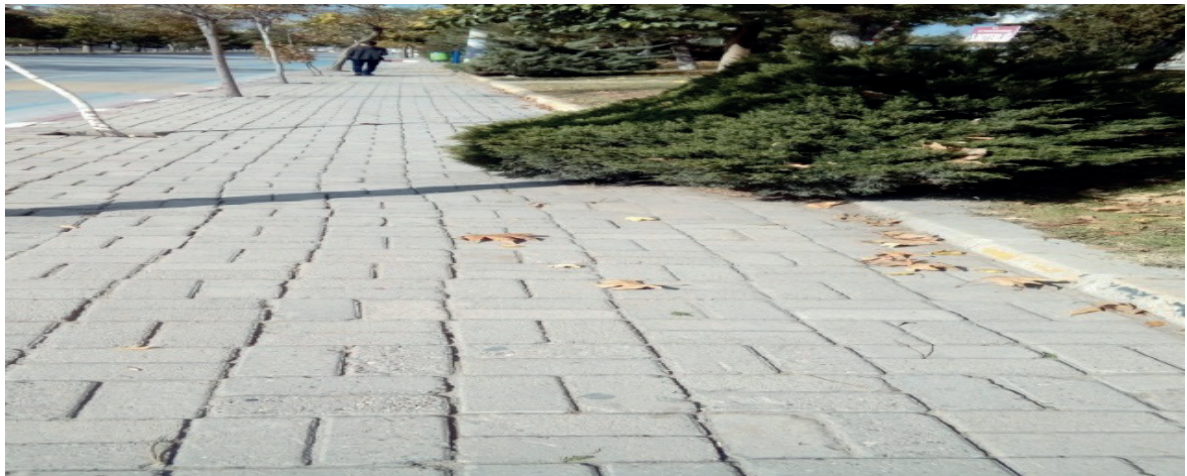
Picture 1. Juniperus communis, located in the grass area, prevents walking on the sidewalk.

On the sidewalk the keystone is used as flooring. *Juniperus communis*, located in the grass area, prevents walking on the sidewalk because there is no pruning.

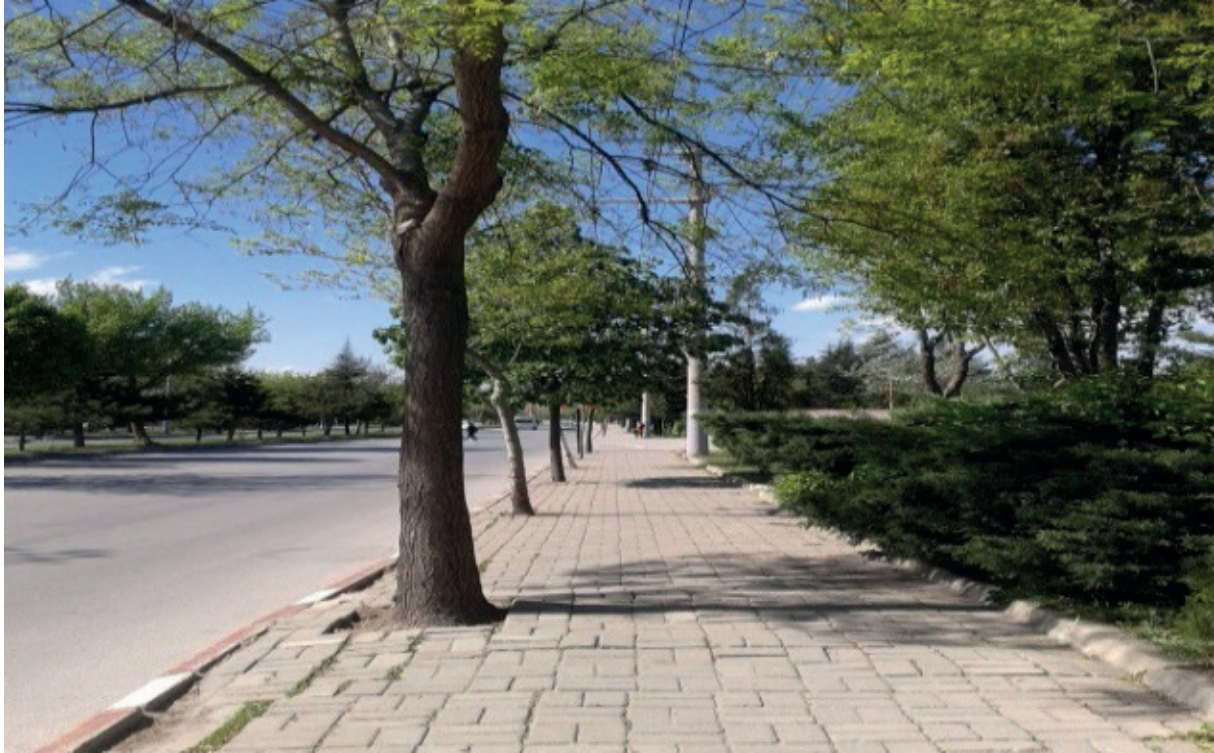
Picture 2. View of sidewalk

The species used on the sidewalk generally provide shade for the spring because they are broad crown species. However, there were adverse effects such as edge cracks and fluctuations in the upholstery in the parts where the wooden pavilion was on the sidewalk

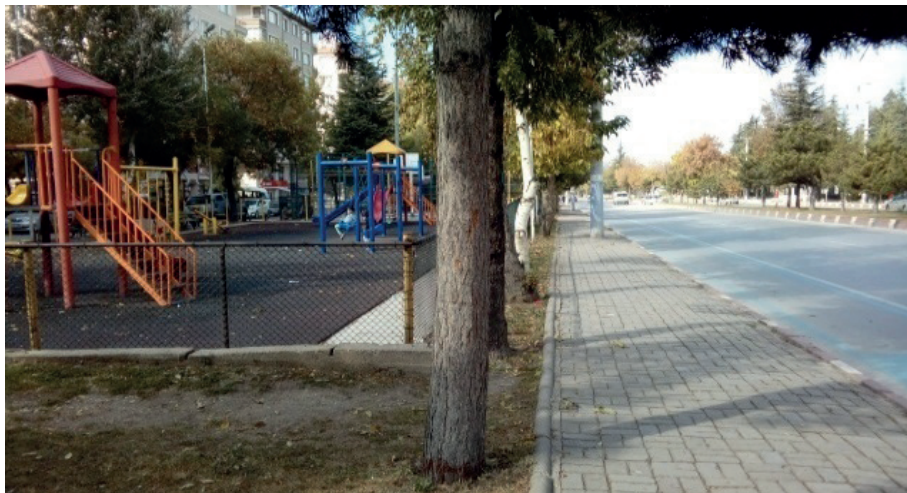
Many of these plant species used in the park due to their thorny species is not suitable for children's playground and seating area. The play area of the children's playground is covered with rubber and iron and wire mesh around it. The park is designed for children aged 2 to 6 years old, with no plaything for older children.

Picture 3. The view of children's playground

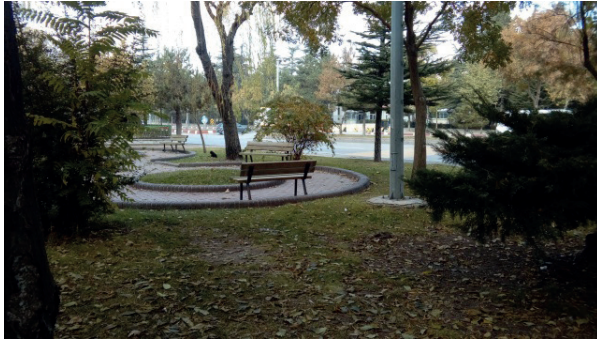
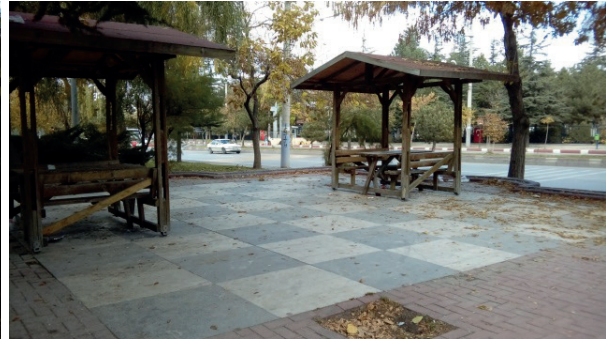
Seating areas were built in the grass area opposite the garrison command. Woods are used as materials on benches placed on hard ground. Apart from the bank, covered seating elements are also used. The biggest problem in the banks is not being fixed.

Picture 4. Seating areas were built in the grass area

- On Adnan Menderes Boulevard, benches with roadside parking are not fixed. This has caused people to randomly place and use benches.

- The benches used on the roadside areas as resting places should be fixed and placed as often as possible in order to prevent them from being transported elsewhere.

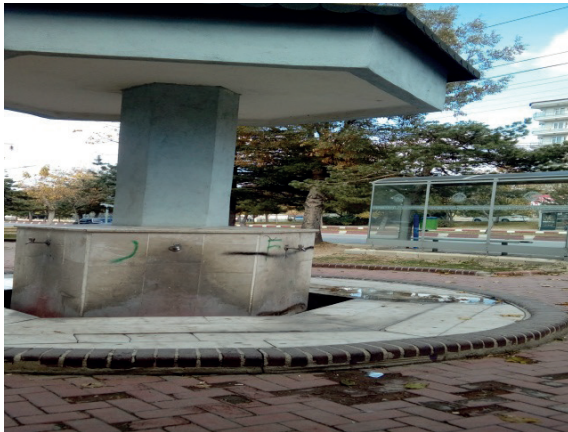
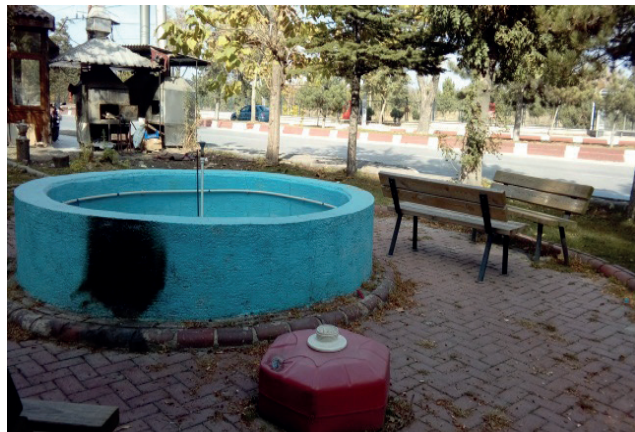
There is a pool and a fountain as a water area for the field. The fountain is made of marble quite large. It is incompatible with the area as size and material. The pool is not aesthetic in terms of both its position and design.

Picture 5. Pool and fountain

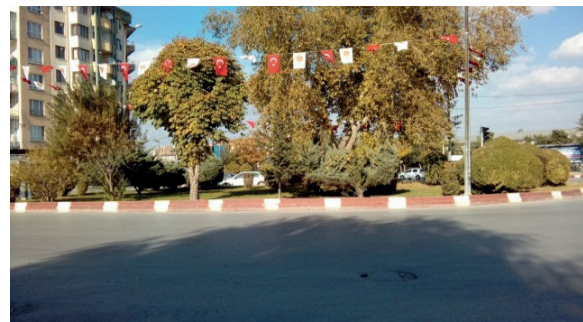
Although the *Platanus orientalis* is suitable for use at the crossroads, the random planting of other species has caused an ugly appearance.

Picture 6. Crossroads

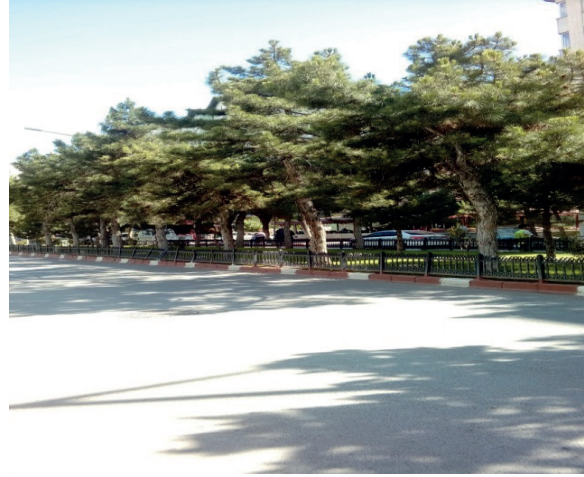
The middle refuge is 3-4m wide and the ground is grass. There are species such as *Platanus orientalis*, *Fraxinus excelsior*, *Pinus nigra*, *Salix babylonica*, *Cedrus libani*, *Picea orientalis*, *Picea pungens* var. *glauca*, *Robinia pseudoacacia*. The intensive use of conifer species is a misguided idea that these species are adversely affected by the exhaust gas. The biggest deficiency observed in the refuge is that it is not included in the species from the *Symphoricarpos albus* as a bush.

Picture 7. Conifers

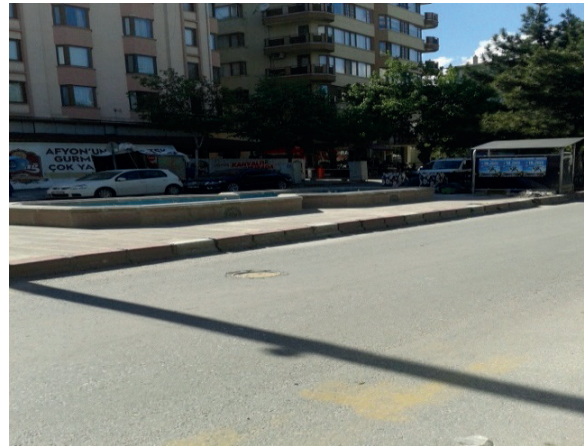
There is a pool about every 250 m in the refuge and this area is intensely planted. The use of the pool has added a movement to the street. The only problem is that people do not pay attention to regular and clean use. The refuge is restricted to iron fences and the passage of people outside the pedestrian path is blocked.

Picture 8. Pools

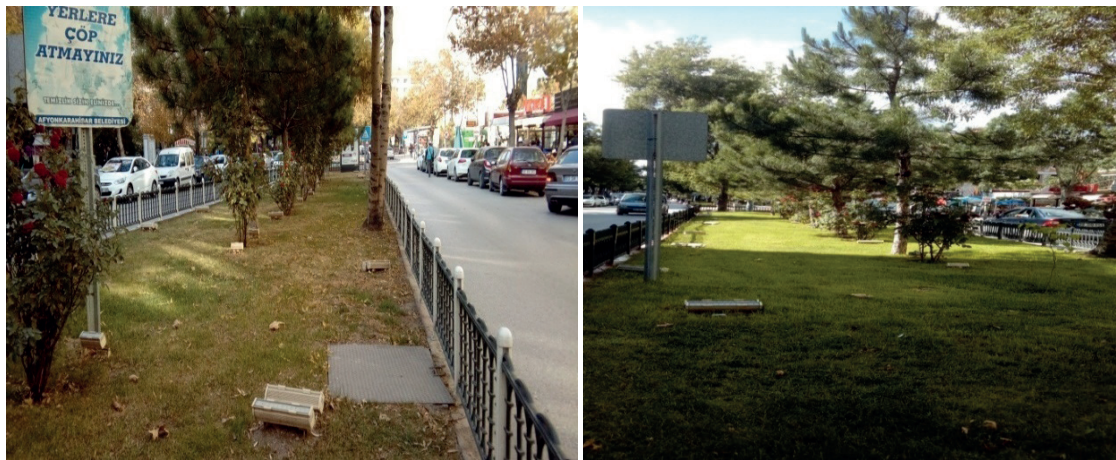
Rosa damascana was used under the medieval trees in the part where the cafes were crowded on the street. Along with this, besides high lighting in the refuge, low lighting is used. All of these have been effective uses in the aesthetics in the refuge.

Picture 9. *Rosa damascana*

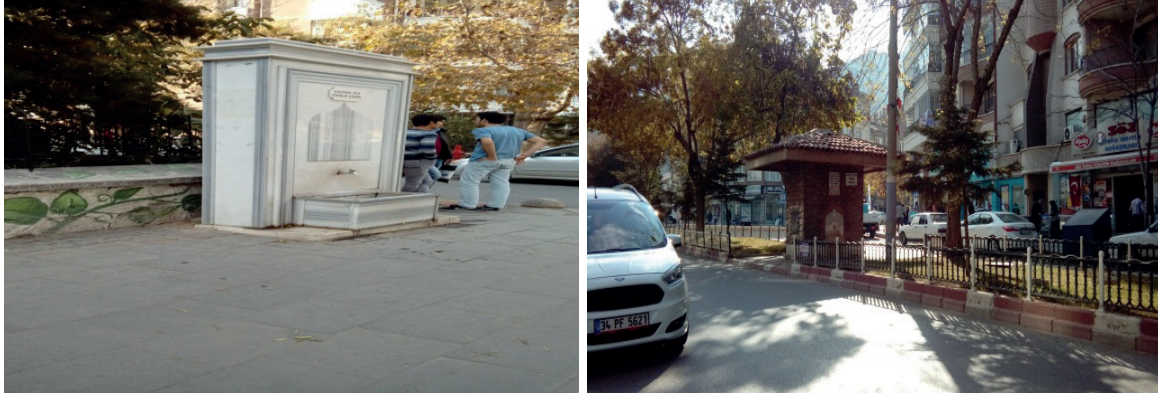
There are two fountains in the refuge and on the sidewalk. As well as being useful for people's use, it also provides a nice view on the street in terms of design.

Picture 10. Fountains

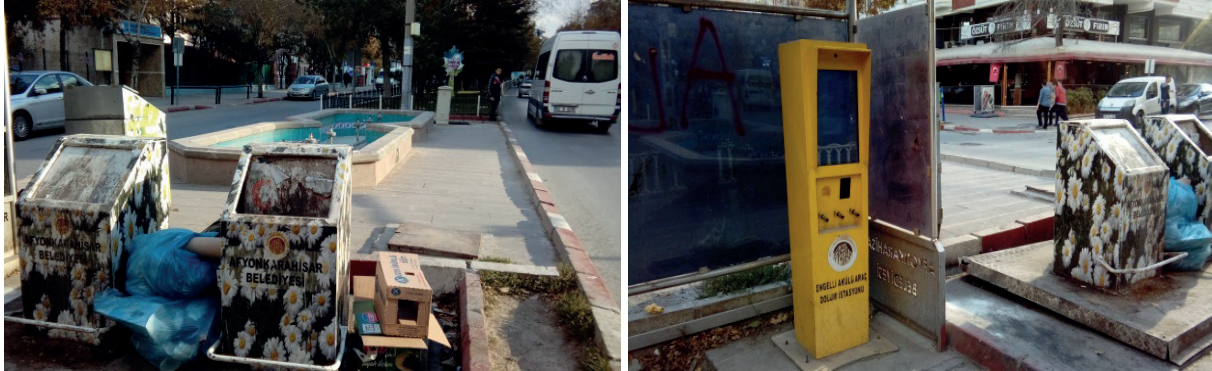
There are garbage cans and disabled cordless car charging stations in areas where pedestrian roads exist in refuges. Along with these, the mirrors that relieve certain point of view are placed.

Picture 11. Garbage cans and disabled cordless car charging stations

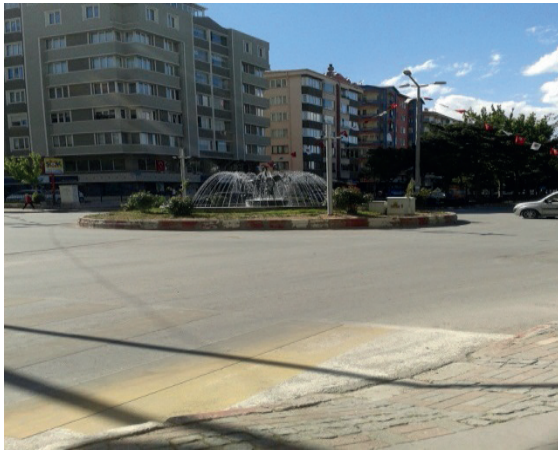
There is a pool at the intersection of Alparslan Türkeş and Ordu Boulevard. The pool is not well maintained. *Rosa damascana* are used for landscaping.

Picture 12. Pool at the intersection of Alparslan Türkeş and Ordu boulevard

- Visually effective pools should be maintained regularly.
