RISKS IN CHILDREN'S PLAYGROUNDS: A CASE STUDY OF BUCA, IZMIR

With this study, it is aimed to reveal the existing risks by evaluating the factors that may pose a risk in children's playgrounds in the example of Buca District, İzmir.

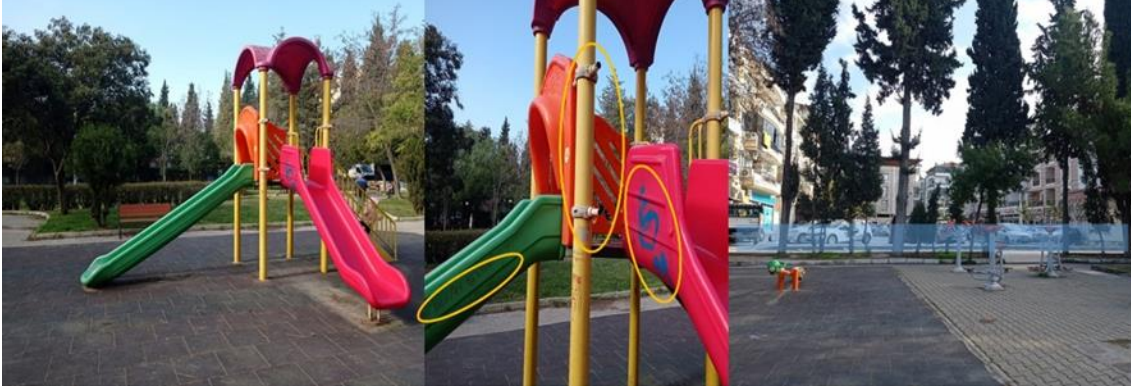
Fig. 2. Fırat Yılmaz Çakıroğlu Park (Original, 2021).

Fırat Yılmaz Çakıroğlu Park is located on a very lively main street. There is no restrictions or obstacles such as walls, fences between the main street and the area. It was observed that the slide railing in the playground was removed from the place where it was mounted, it was not repaired, writings were written on the playground equipment and the equipment was damaged (Fig. 2).

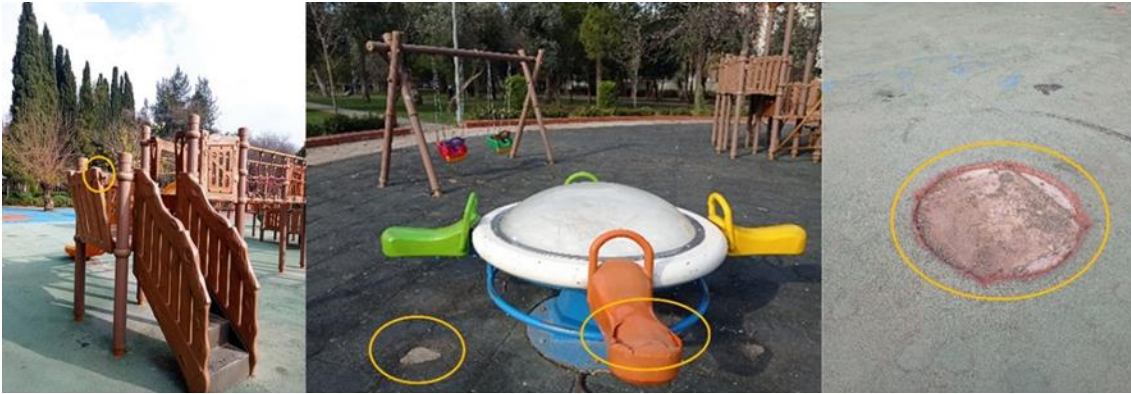
Fig. 3. Hasanağa Bahçesi (Original, 2021).

Hasanağa Bahçesi is one of the most popular open green spaces that appeal to many users. Multiple playgrounds in the area allow children to freely choose between toys and play equipment. Thanks to this diversity, children can play in the area without getting bored. However, it was determined that some toys and playground equipment in the area were broken and damaged, and there were occasional tears and gaps in the rubber flooring (Fig. 3).

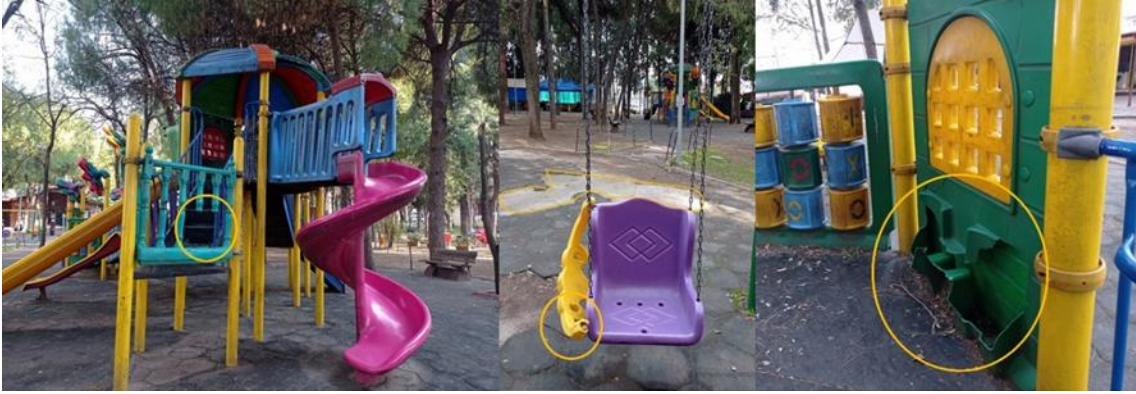
Fig. 5. Şirinyer Park (Original, 2021).

Şirinyer Park is surrounded by coniferous trees and receives little sunlight. Most of the park equipment was damaged, the maintenance and the cleaning of the area is insufficient. In addition, major damages were detected on the surface material of the park. The broken pieces of the equipments and the damaged surface material pose a risk to children (Fig. 5).

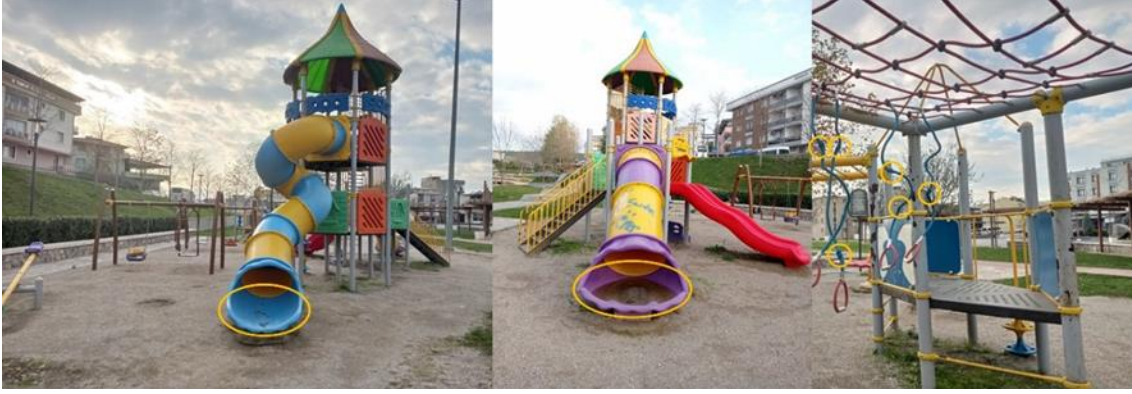
Fig. 6. Neşet Ertuş Park (Original, 2021).

The ground of Neşet Ertaş Park is covered with sand. It was observed that pits had formed on the ground with occasional collapses. It was foreseen that the formed pits might cause children to lose their balance, fall and injuries during the game. In addition, some abrasions were detected on the climbing ropes in the playground. Maintenance should be done as this situation may cause accidents in the future. One of the two slides in the area could not be used safely due to the accumulation of water in the exit part and the other due to fractures in the same place (Fig. 6).

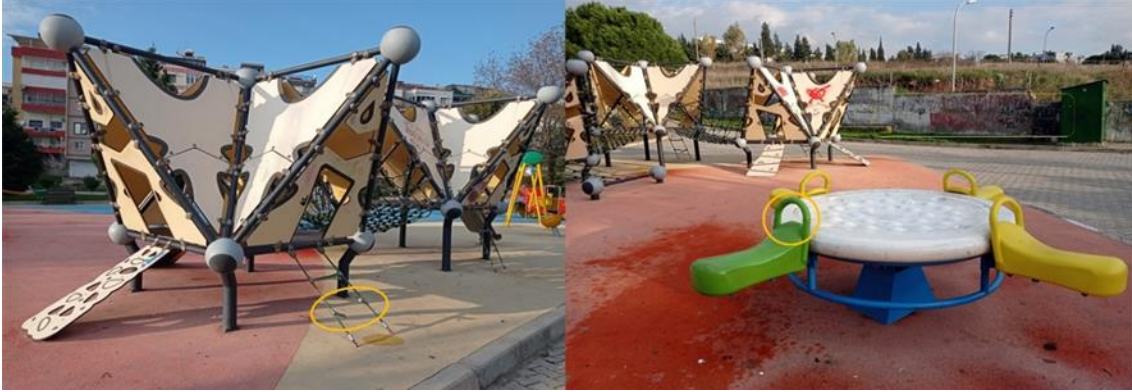
Fig. 7. Bahçekapı Park (Original, 2021).

The surface material of the playground in Bahçekapı Park was rubber. Damage to the handle of the game equipment and inscriptions written with spray paint indicated vandalism. No security problems were identified in Bahçekapı Park. Among the parks examined, the only playground found to be risk-free (Fig. 7).
